# Northeast Aquatic Research

## 2021 Monitoring Report

Article 409 Nuisance Plant Monitoring of Lakes;  
Candlewood, Lillinonah, and Zoar

Prepared for FirstLight Power  
November 2021

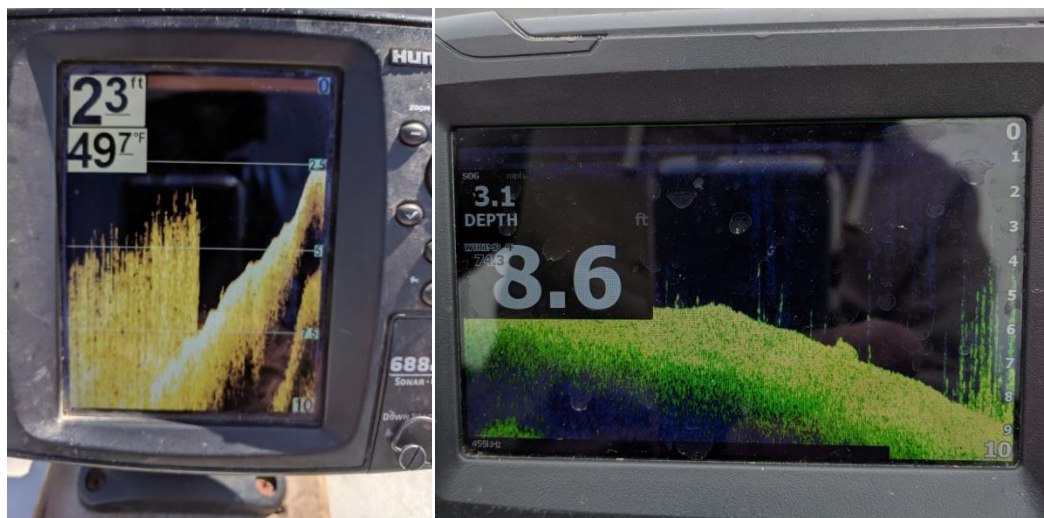
*Image 1. Down-imaging SONAR images showing edge of milfoil coverage and the height of milfoil plants.*

The second method used to estimate percent cover of vegetation is to use down-imaging SONAR, which shows a detailed image of the plants as the boat passes above (**Image 1**). In this photo, milfoil is shown reaching to about 3 feet from the surface in both images. Plants in the first image begin growing at 7.5ft deep, while milfoil plants in the second image are very sparse in shallow water and dense starting at 8ft. The boat is at far right at time of depth readout in both images.

The down-imaging SONAR device is also used to estimate plant height in the water column, as well as the water depth. In almost all cases in Candlewood Lake, Eurasian milfoil reached to only 1-2 feet from the surface. Survey methods involve a number scale of 1 to 5 in estimating plant height (also known as “growth form”) in the water column.

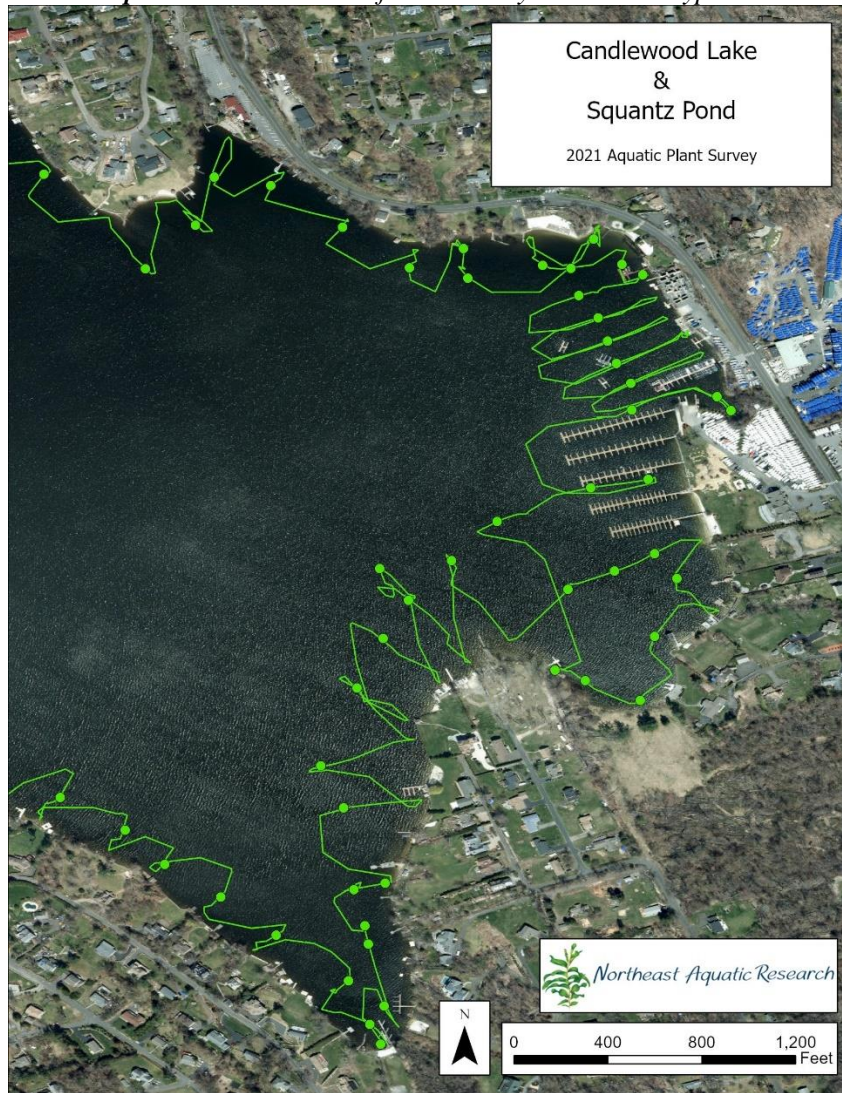
**Map 1.** Zoomed section of 2021 survey track and waypoints.

The boat was driven in a zig-zag pattern along the shoreline, as described in the above section (**Map 1**). The boat was driven away from shore until reaching the outer edge of the milfoil as could be seen on the depth sounder and verified by the throw rake. The boat was then turned and driven towards shore until reaching the inner edge of the milfoil bed. As previously mentioned, in areas where the littoral zone was very narrow, the boat was driven in a straight line rather than a zig zag pattern.

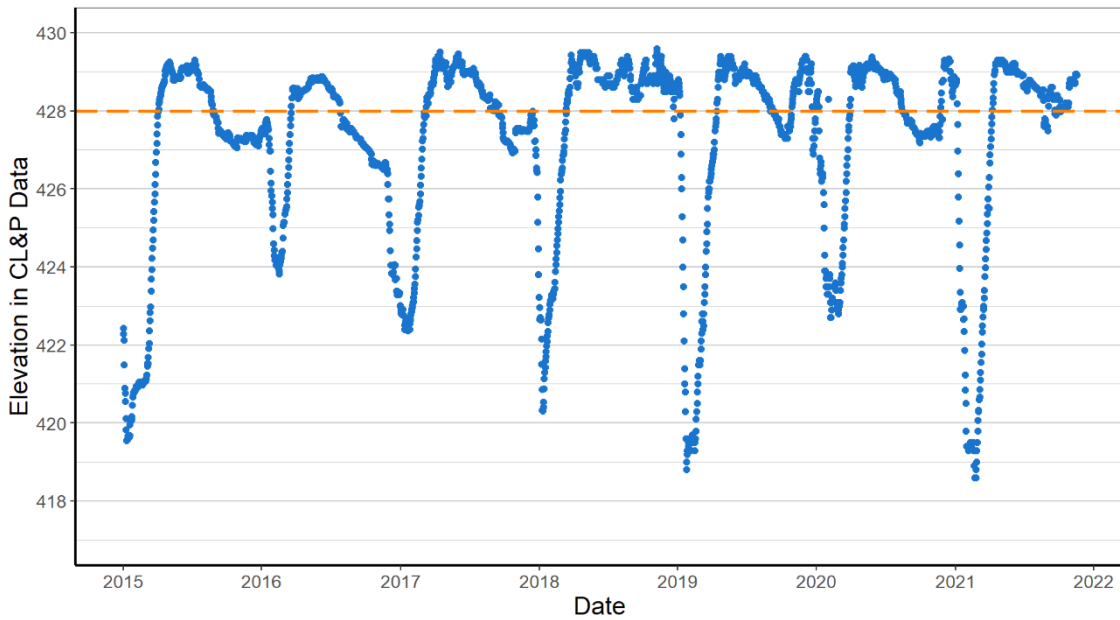
**Figure 2.** Water levels at Candlewood Lake between Jan. 1, 2015 and November 16, 2021. Average summer elevation indicated with orange vertical dashed line. (DATA Provisional).

Each winter, Candlewood Lake is drawn down to varying depths ranging from ~4 feet to ~9.5 feet. A deep drawdown was conducted in the winter of 2020-2021, when the lake reached a maximum drawdown depth of -9.4 feet. This is the deepest drawdown in at least the past six years.
